Manhole Inspection Summary

Manhole # S41II_031MH

Insp Date: **9/1/09 10:03 AM**

Location Address: **HARFORD AVE**

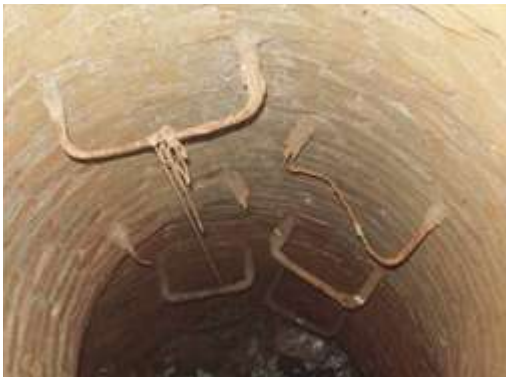
Defect 1

Count: **5** Missing: **0** ☒ **Corroded**

CORROED STEPS

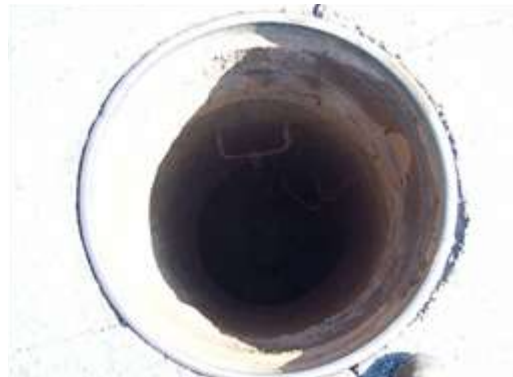
Defect 2

Offset: **2** (in.)

frame offset

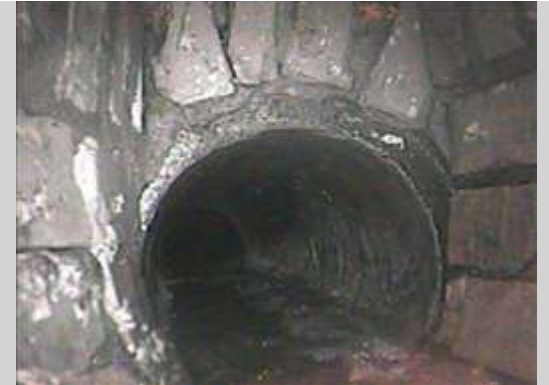
12 O'Clock Outflow

8 in. Circular Gravity Sewer
Pipe Out @ 12 O'Clock

Pipe Height: (in.) Direct
Pipe Material: **Clay** ☐ Pipe Lined
Invert Depth: **12.67** (ft.) Flow Characteristics: **Fast**
Deposits: ☒ None ☐ Mud ☐ Sludge ☐ Debris ☐ Grease
Silt Depth: (in.) Deposits Extent:
Infiltration: **None** Pipe Seal Cond: **Sound**

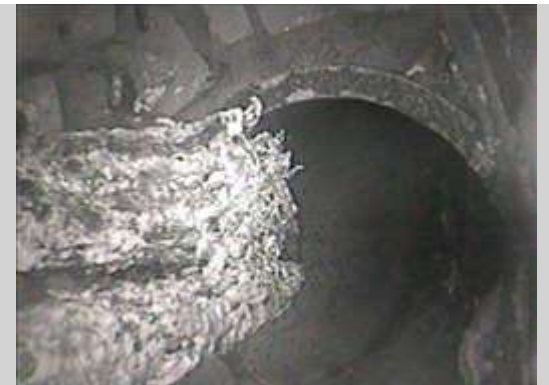
3 O'Clock Inflow

8 in. Circular Gravity Sewer
Pipe In @ 3 O'Clock

Pipe Height: (in.) Direct
Pipe Material: **Clay** ☐ Pipe Lined
Invert Depth: **12.66** (ft.) Flow Characteristics: **Fast**
Deposits: ☒ None ☐ Mud ☐ Sludge ☐ Debris ☐ Grease
Silt Depth: (in.) Deposits Extent:
Infiltration: **None** Pipe Seal Cond: **Sound**

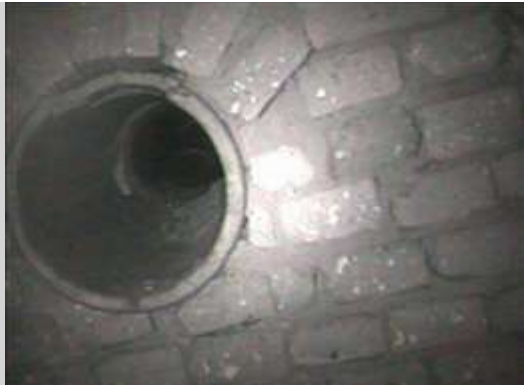
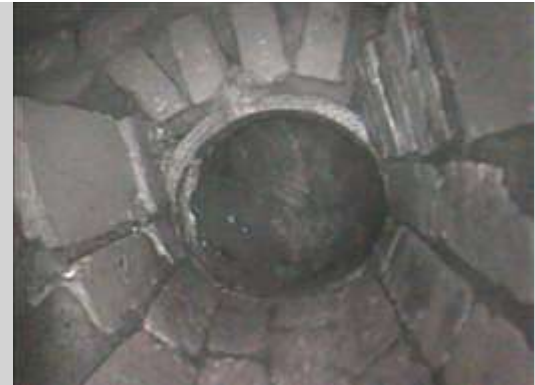
6 O'Clock Inflow

Pipe In @ 6 O'Clock

Drop In @ 6 O'Clock

Invert Depth: **11.00** (ft.) Flow Characteristics: **Fast**

Infiltration: **None** Pipe Seal Cond: **Sound**

Drop: **Inside** **Direct**

Drop Condition: **Open**

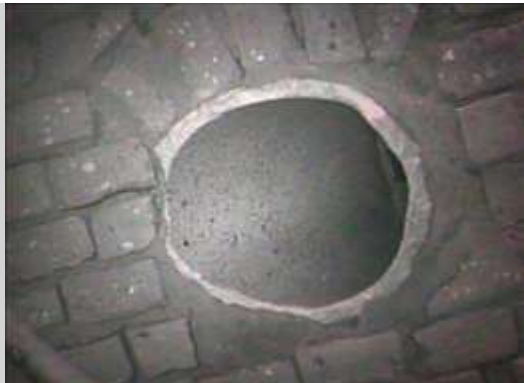
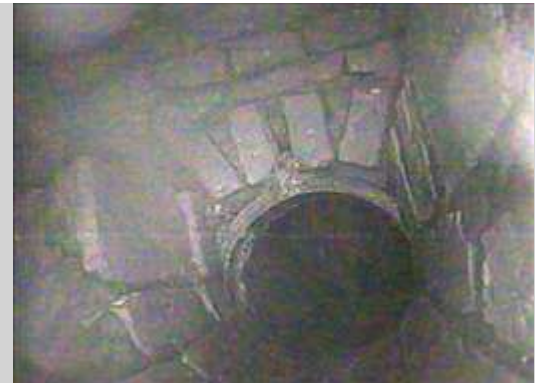
9 O'Clock Inflow

Pipe In @ 9 O'Clock

Drop In @ 9 O'Clock

Invert Depth: **11.48** (ft.) Flow Characteristics: **Fast**

Infiltration: **None** Pipe Seal Cond: **Sound**

Drop: **Inside** **Direct**

Drop Condition: **Open**
